Manhole Inspection Summary

Manhole # S15EE2015MH

Location Address: **2106 WESTERN RUN DR**

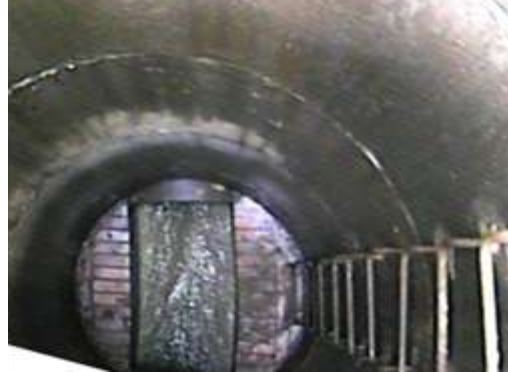
Top View

☒ **Debris** (not Condition related)

Bench debris.

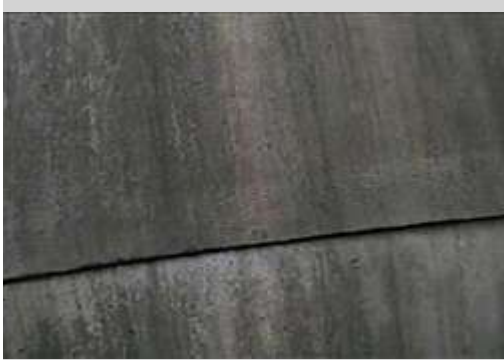
Defect

Infiltration: ☐ None ☒ **Joint** ☐ Cracks ☐ Mortar ☐ Roots ☐ Wall

Corbel infiltration.

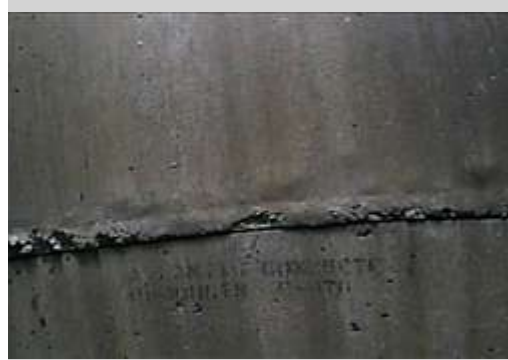
Defect

Infiltration: ☐ None ☒ **Joint** ☐ Cracks ☐ Mortar ☐ Roots ☐ Wall

Barrel infiltration.

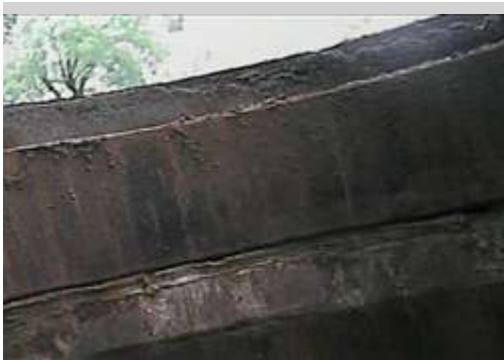
Defect

☒ **Leaks**

Infiltration: ☐ None ☒ **Joint** ☐ Cracks ☐ Mortar ☐ Roots ☐ Wall

Frame leaks. Adjustment infiltration.

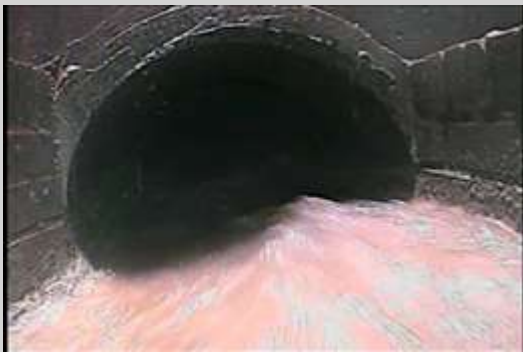
21 in. Circular Gravity Sewer Pipe Out @ 12 O'Clock

Infiltration: **None** Pipe Seal Cond: **Unknown**

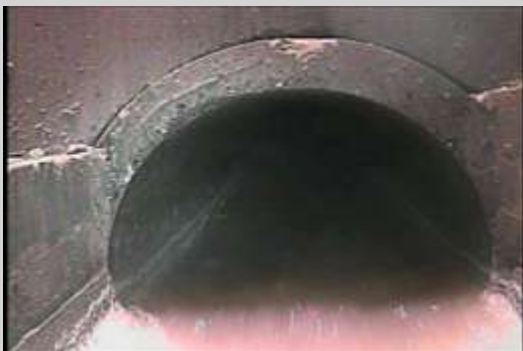
21 in. Circular Gravity Sewer Pipe In @ 6 O'Clock

Infiltration: **None** Pipe Seal Cond: **Unknown**
